PERATION

GREENHOUSE

SCIENTIFIC DIRECTOR'S REPORT

ANNEX 3.2 U. S. NAVY STRUCTURES

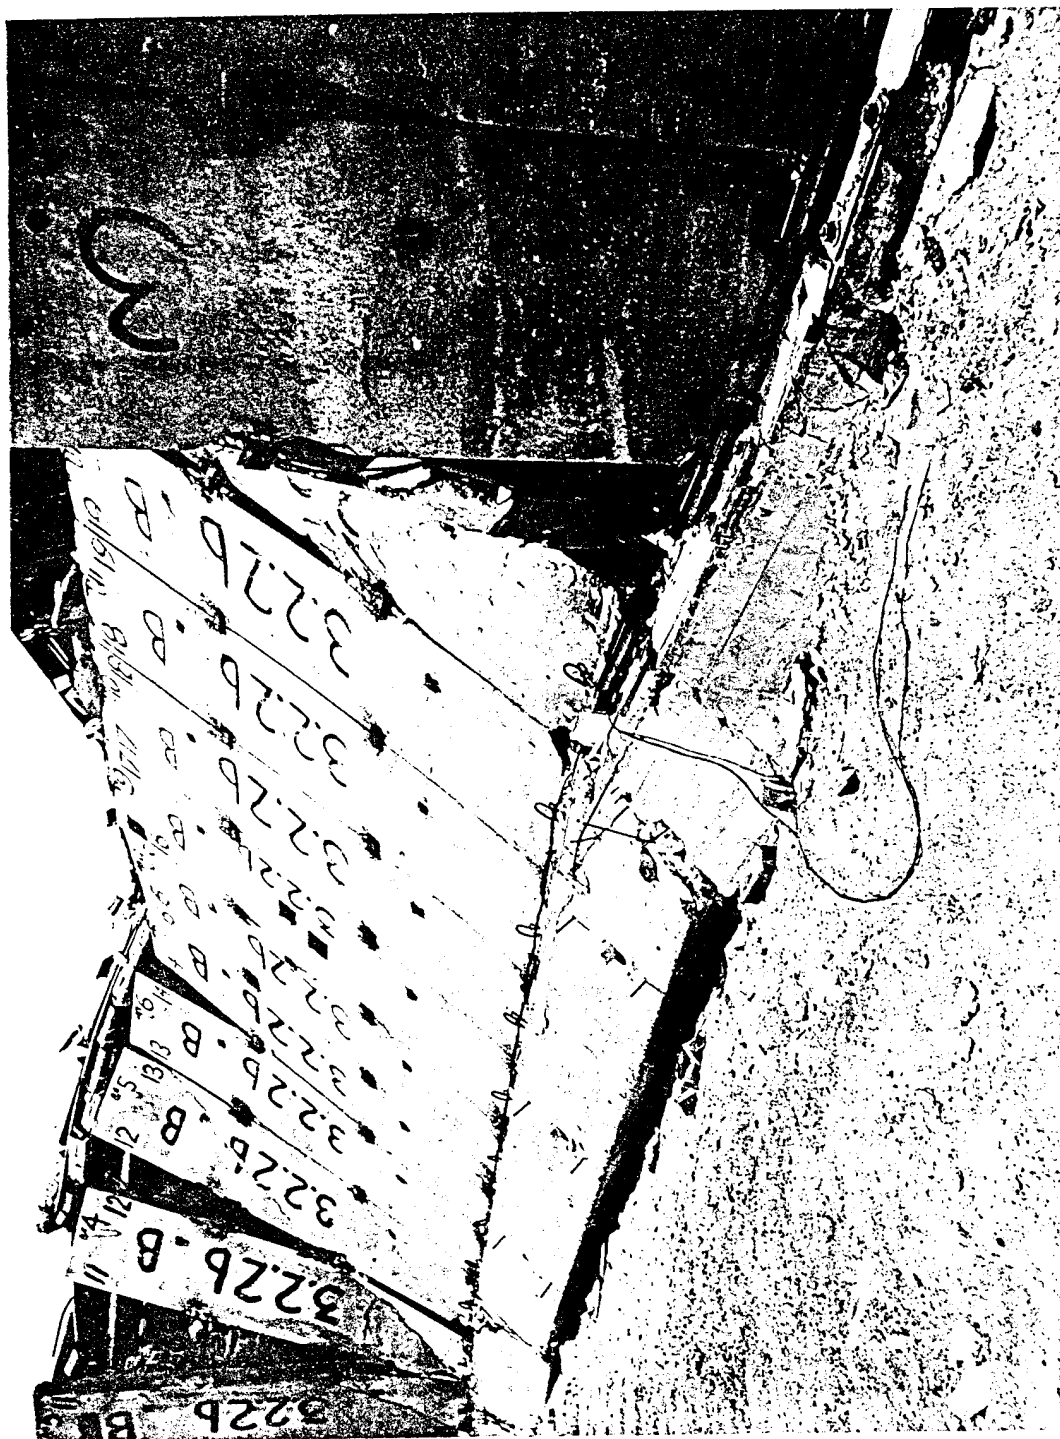
Fig. L.129 Uplifted Panel Footing on Front Wall from Right, Structure 3.2.2b

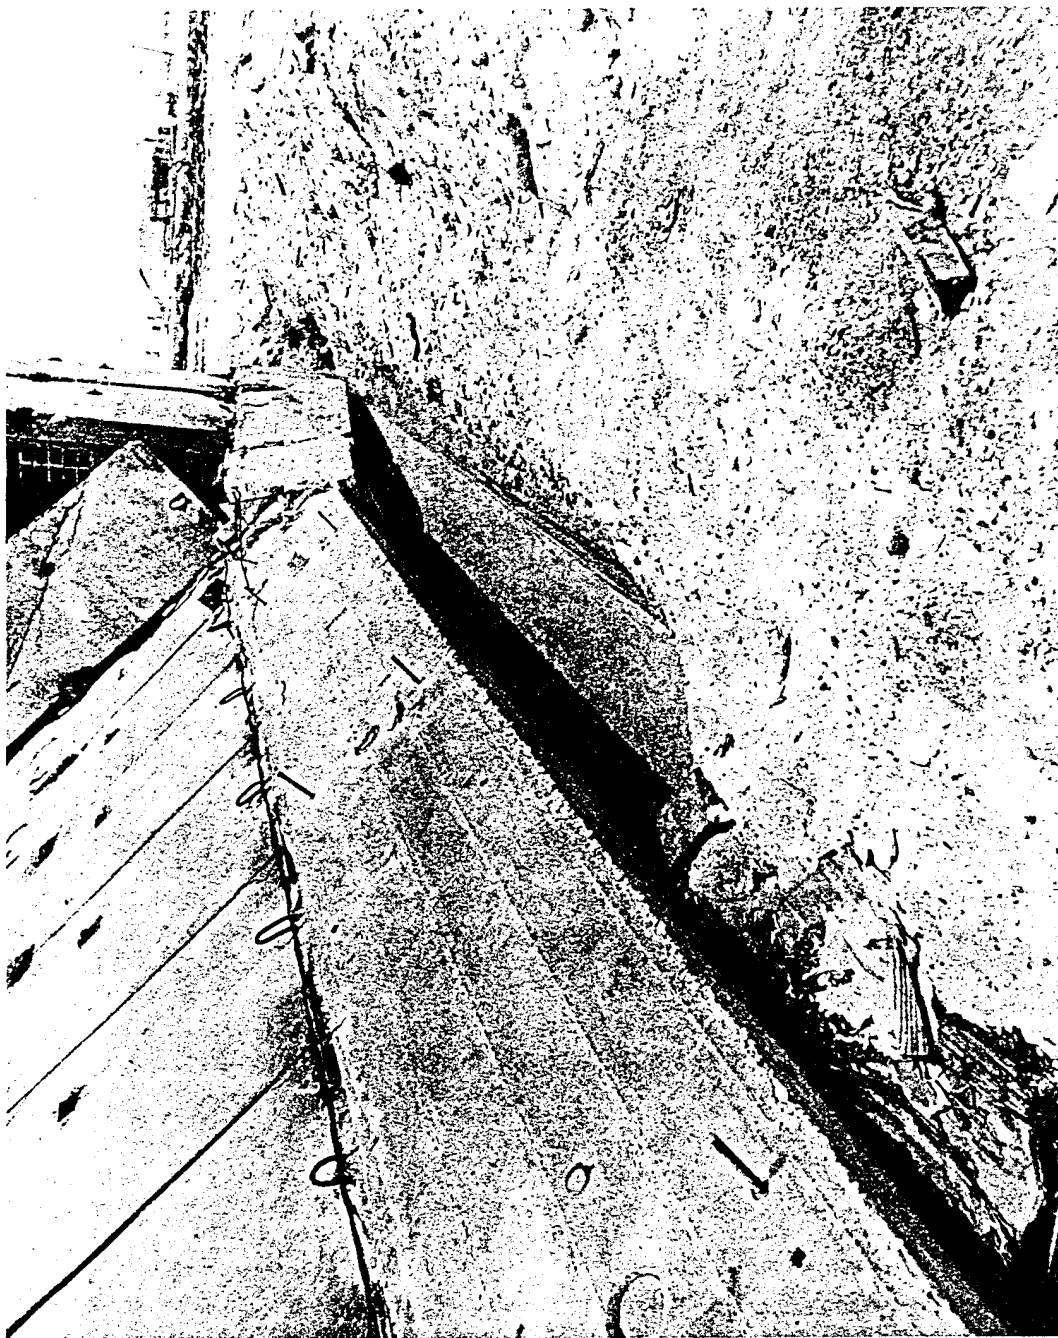
Fig. L.130 Uplifted Panel Footing on Front Wall from Left after Partial Excavation to Expose Foundation on Which
It Rested, Structure 3.2.2b

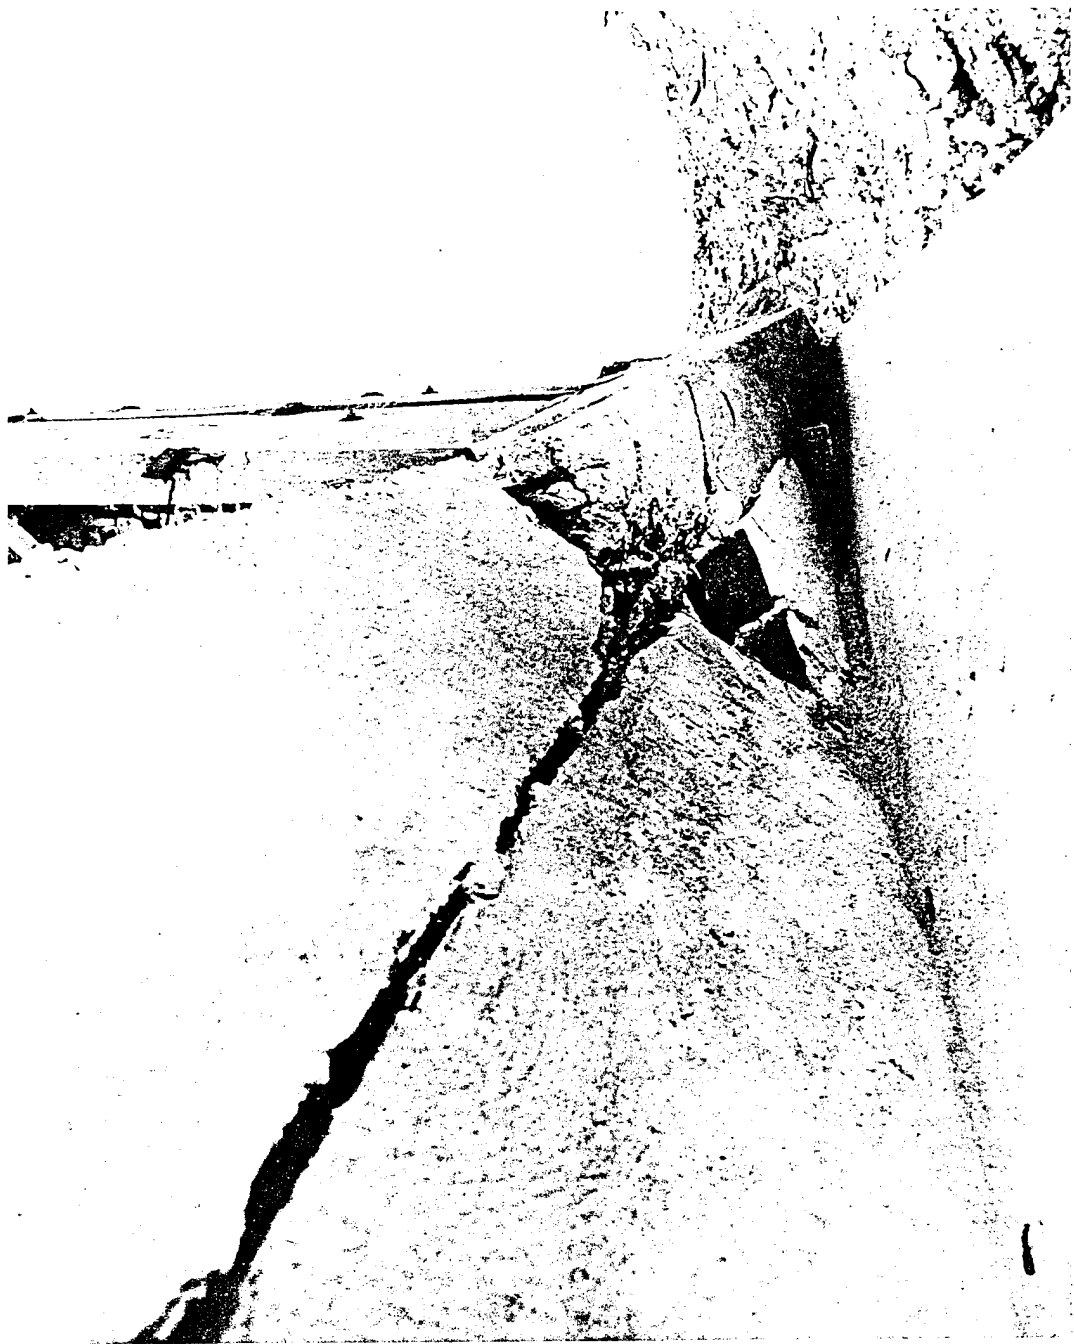
Fig. L.131 Undersurface of Front Panel Footing and Brick Wall, Structure 3.2.2b. Note lack of connection between footing and foundation slab.

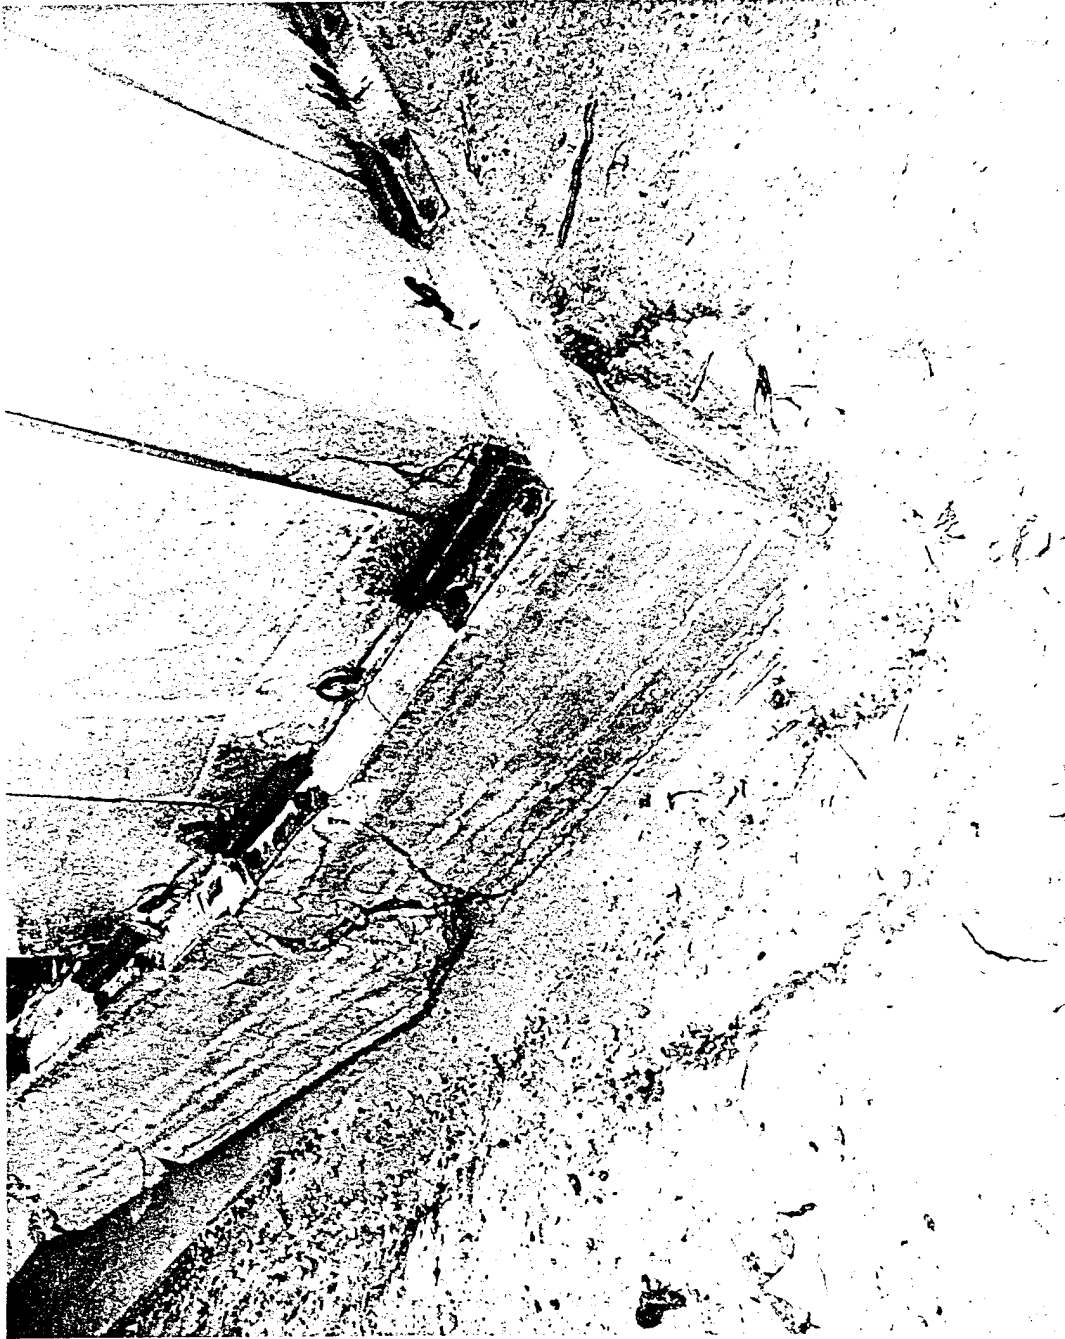
Fig. L.132 Right Front Corner Showing Footing Cracks, Structure 3.2.2b

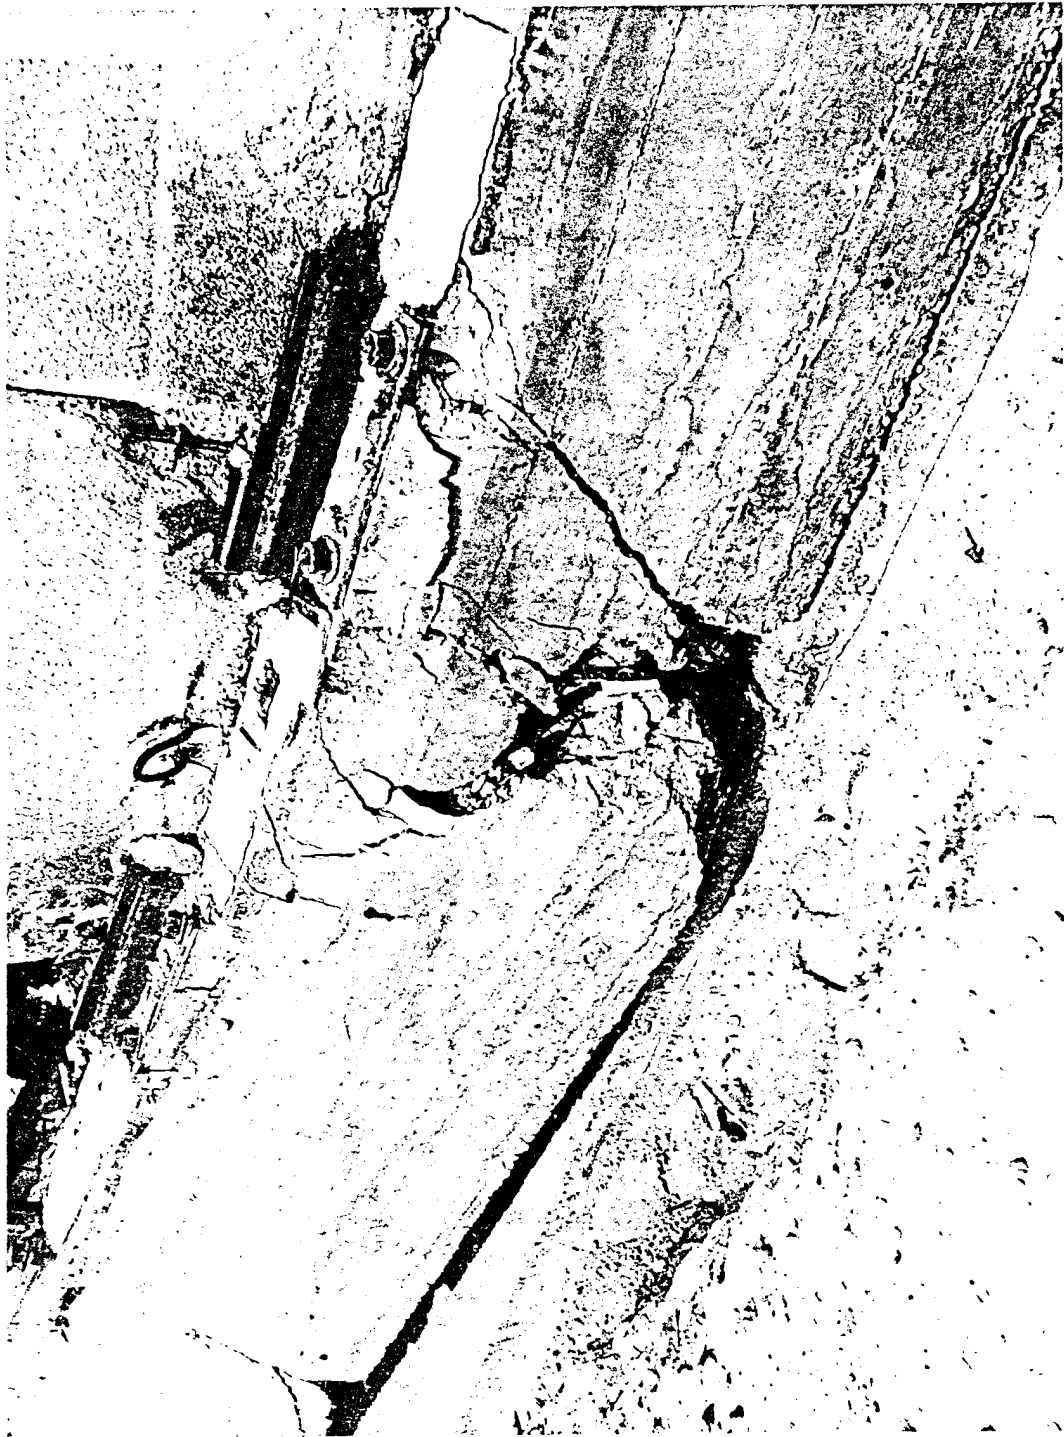
Fig. L.133 Close-up of Footing Near Right Corner, Structure 3.2.2b

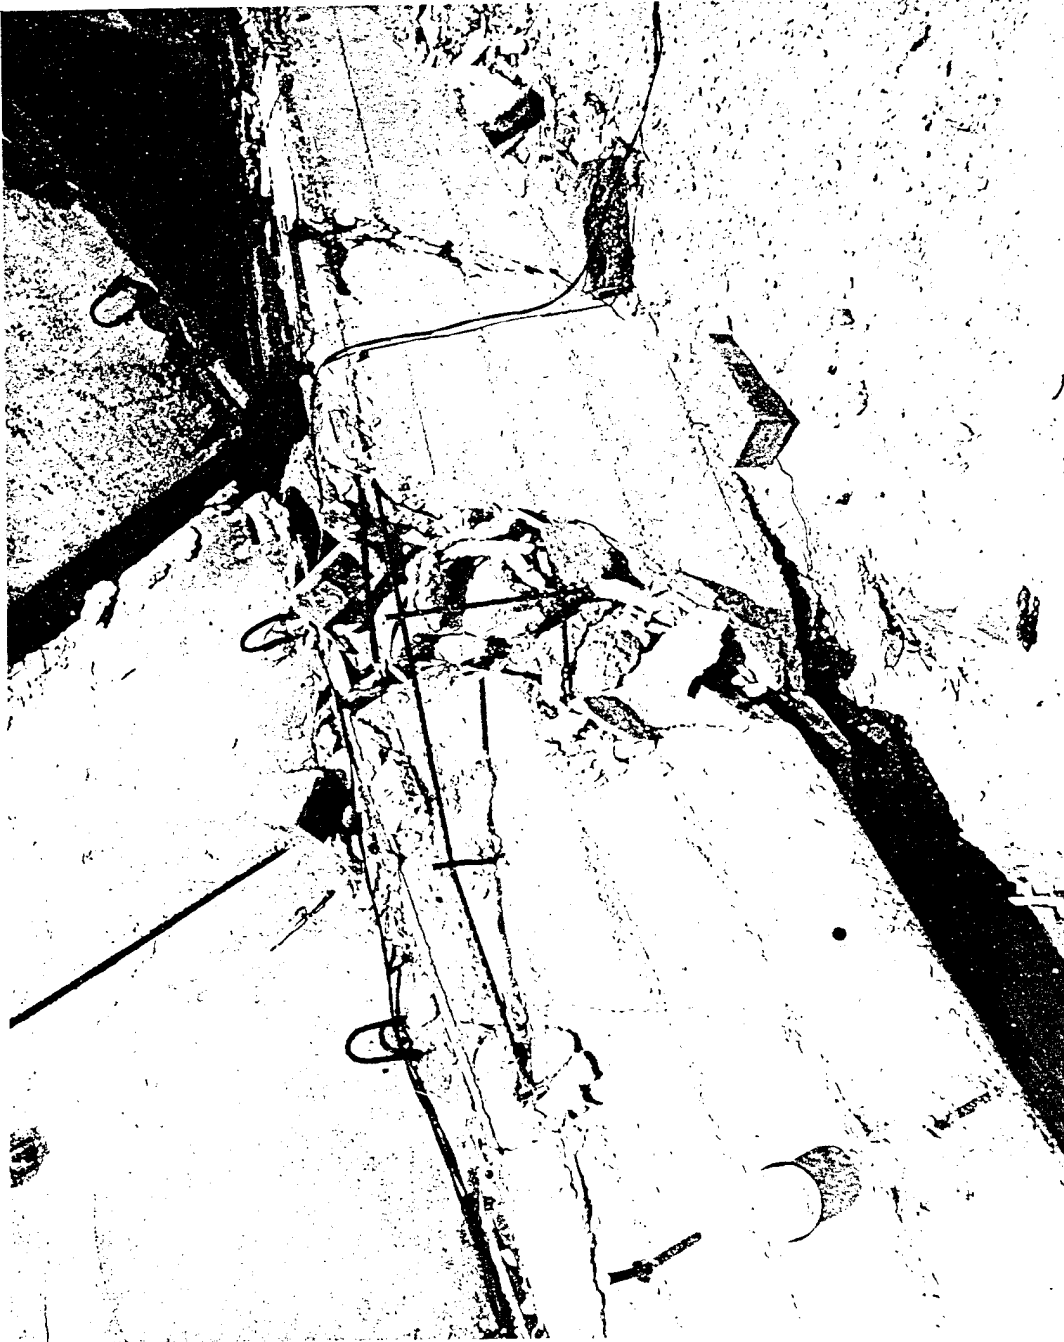
Fig. L.134 Panel Footing 11 ft from Right Front Corner, Structure 3.2.2b

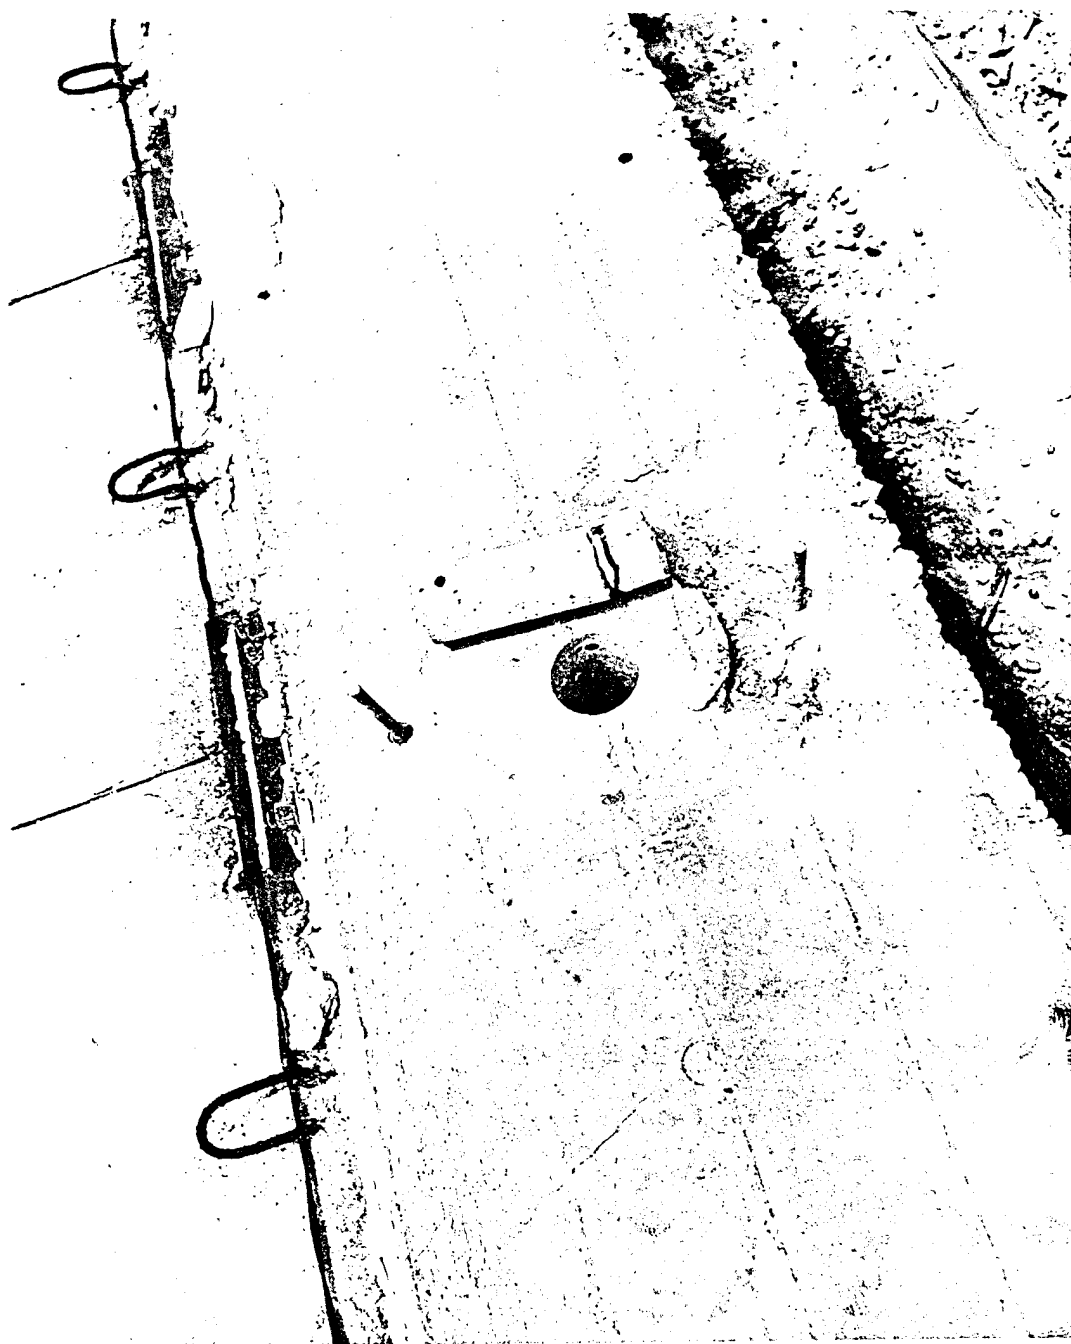
Fig. L.135 Uplifted Panel Footing Near Center, Structure 3.2.2b. Note 3-in. test cylinder.

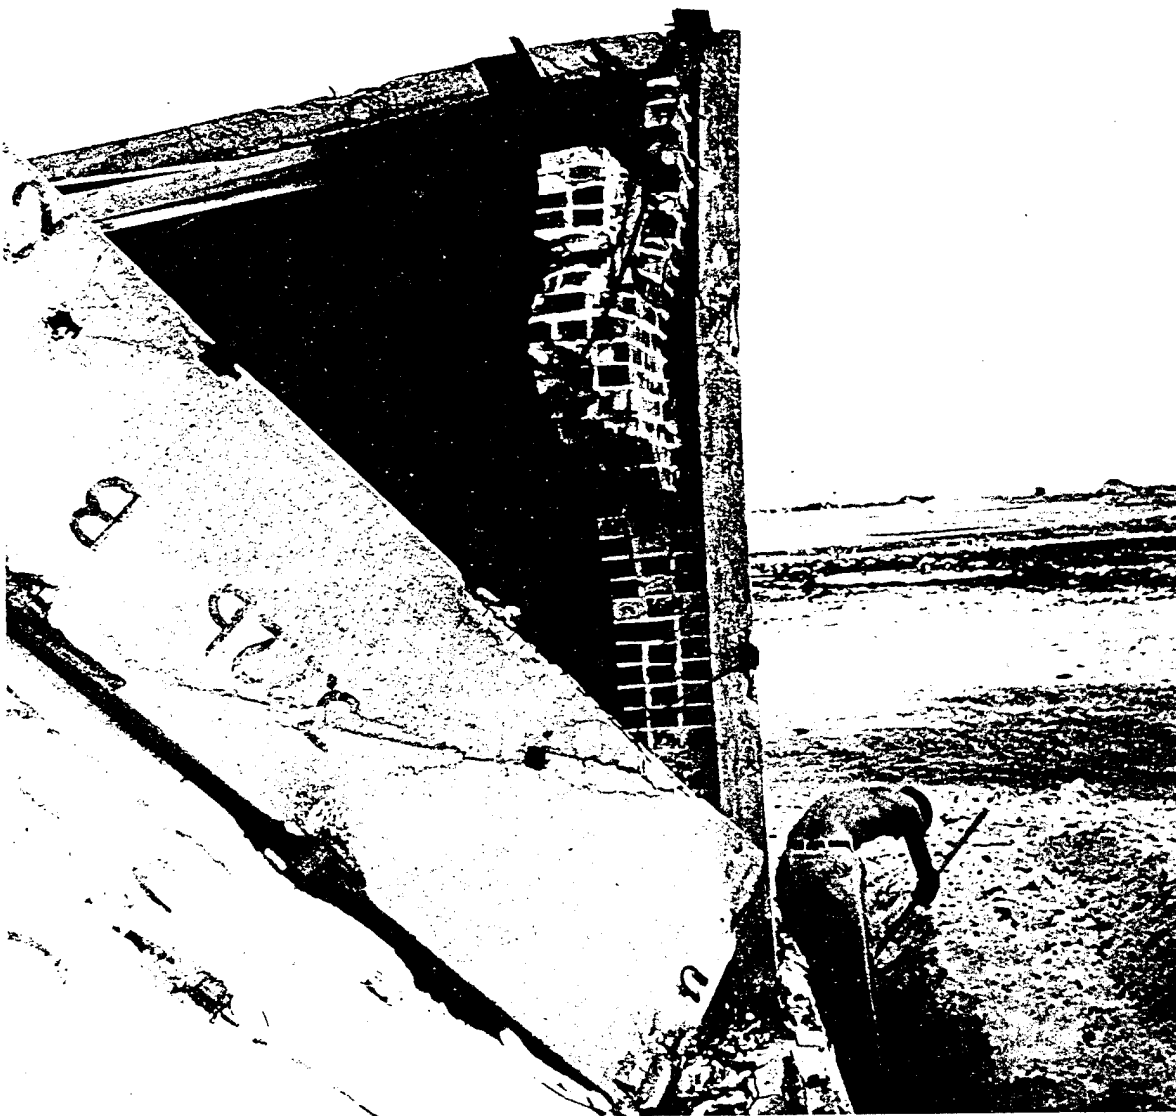
Fig. L.138 Right Front Corner Showing Overhanging Brick and Deformed Panel, Structure 3.2.2b

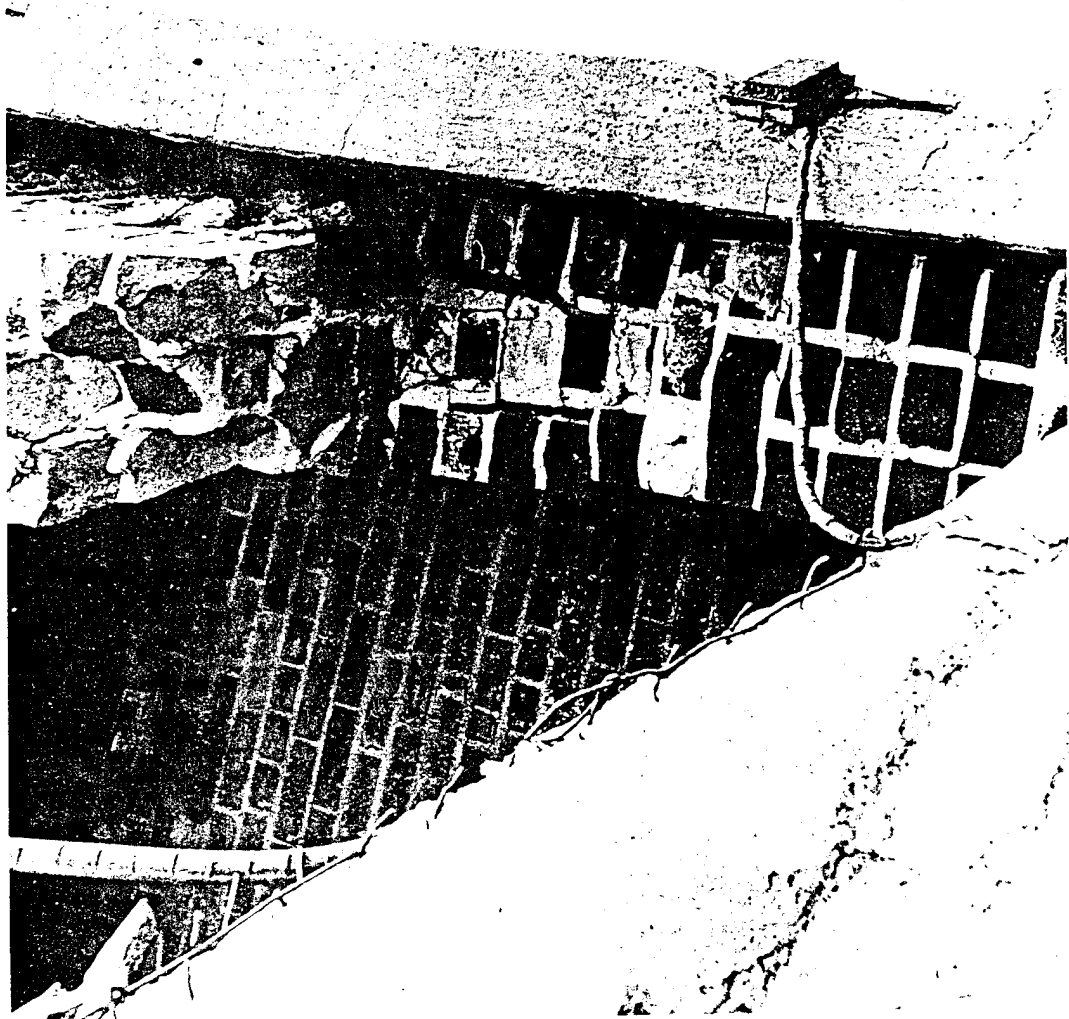
Fig. L.139 Close-up of Brick Near Right Front Corner, Structure 3.2.2b. Note breaks through brick rather than in mortar joints.

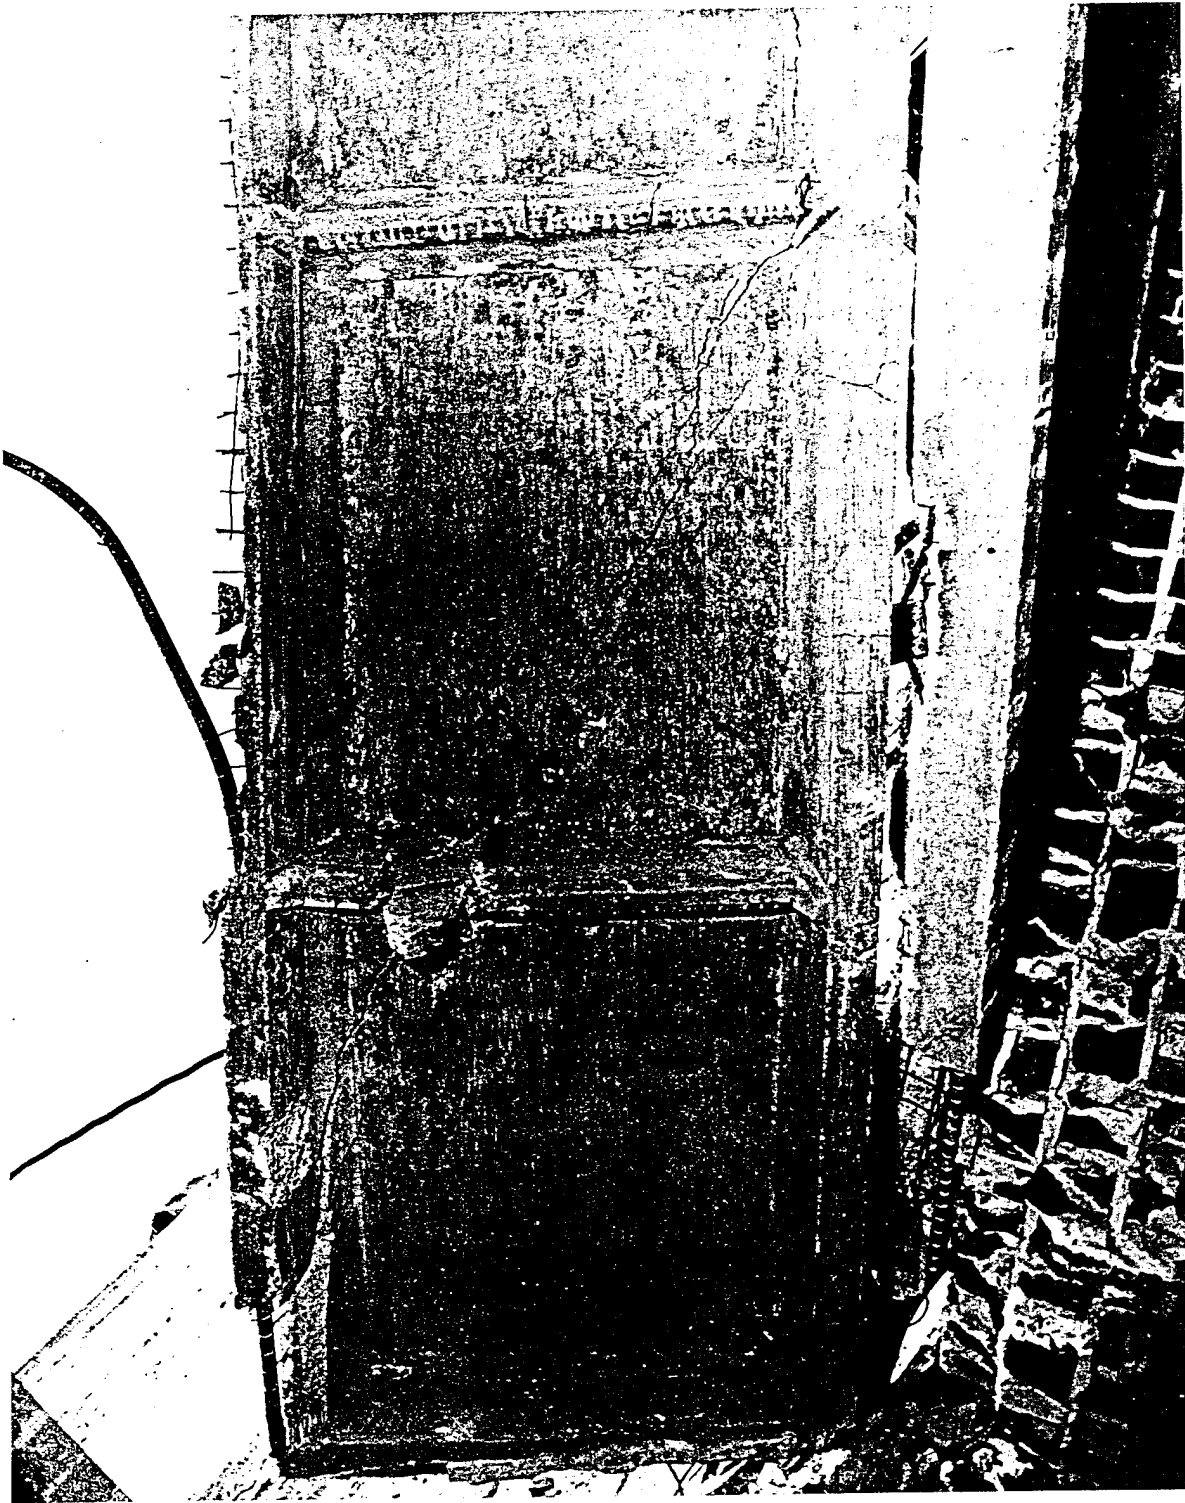
Fig. L.140 Deformations of Sub-ribs on Interior of Front Panel at Right Fold. Structure 3.2.2b

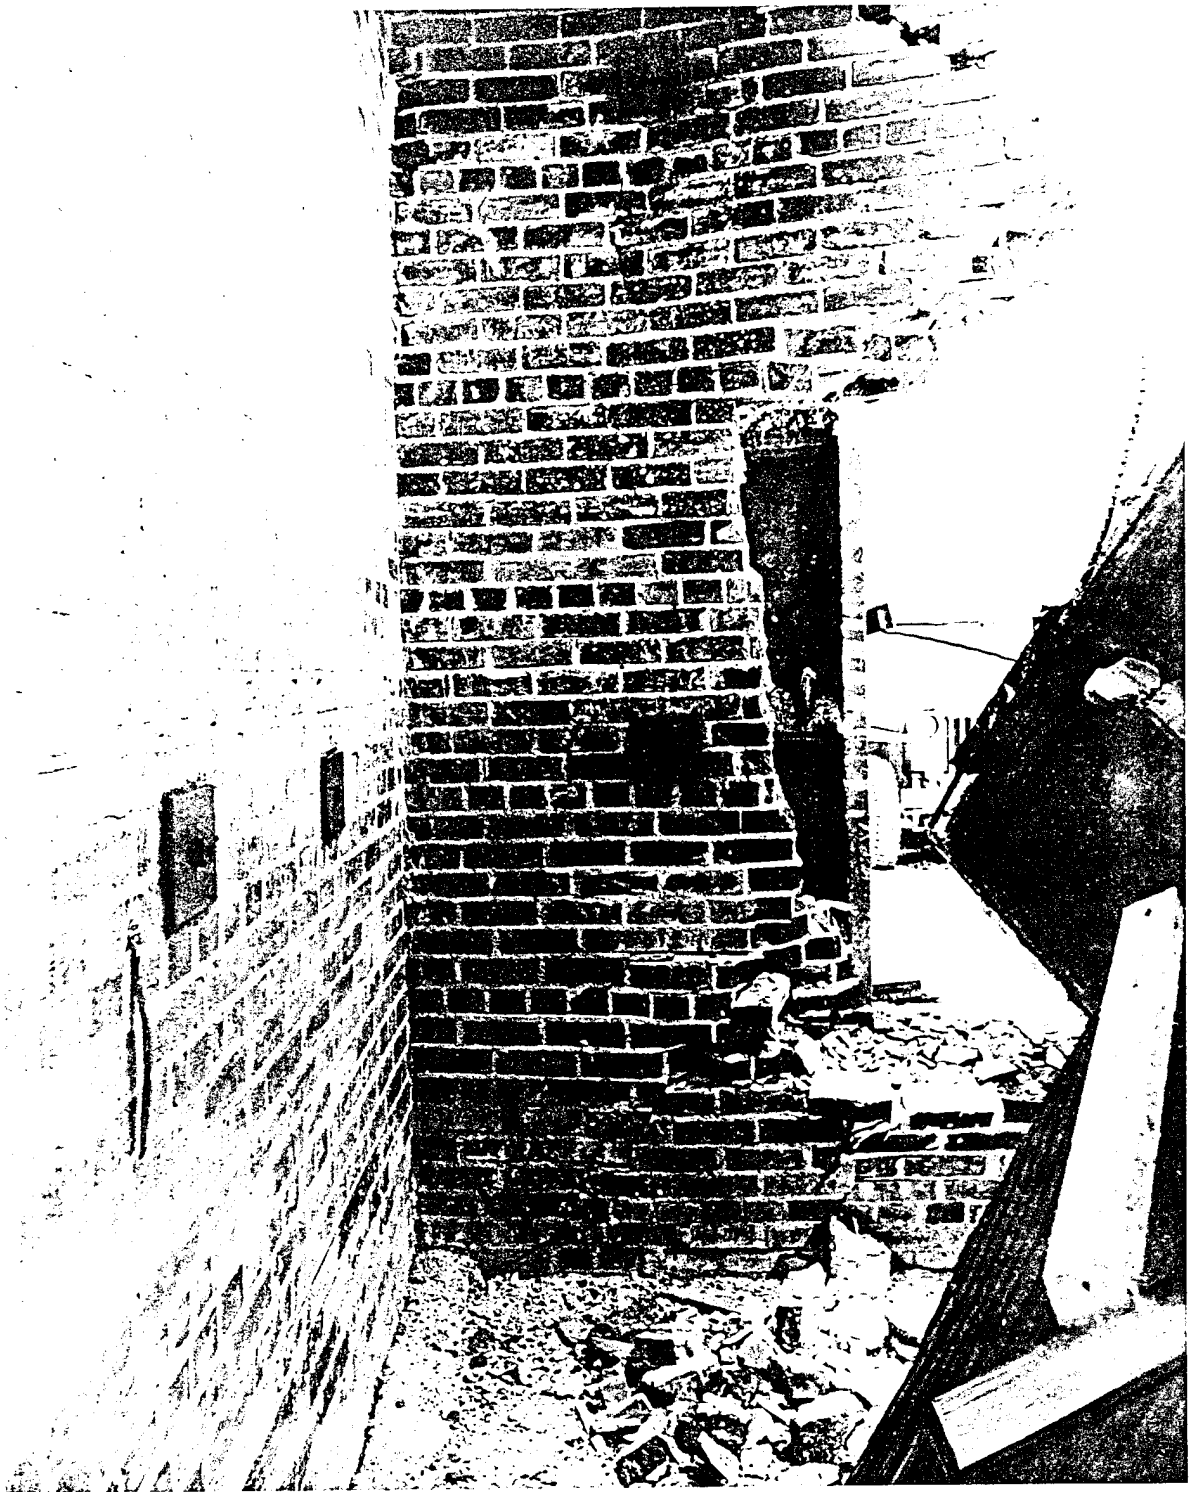
Fig. L.141 Interior of Brick Wall at Right Corner, Structure 3.2.2b

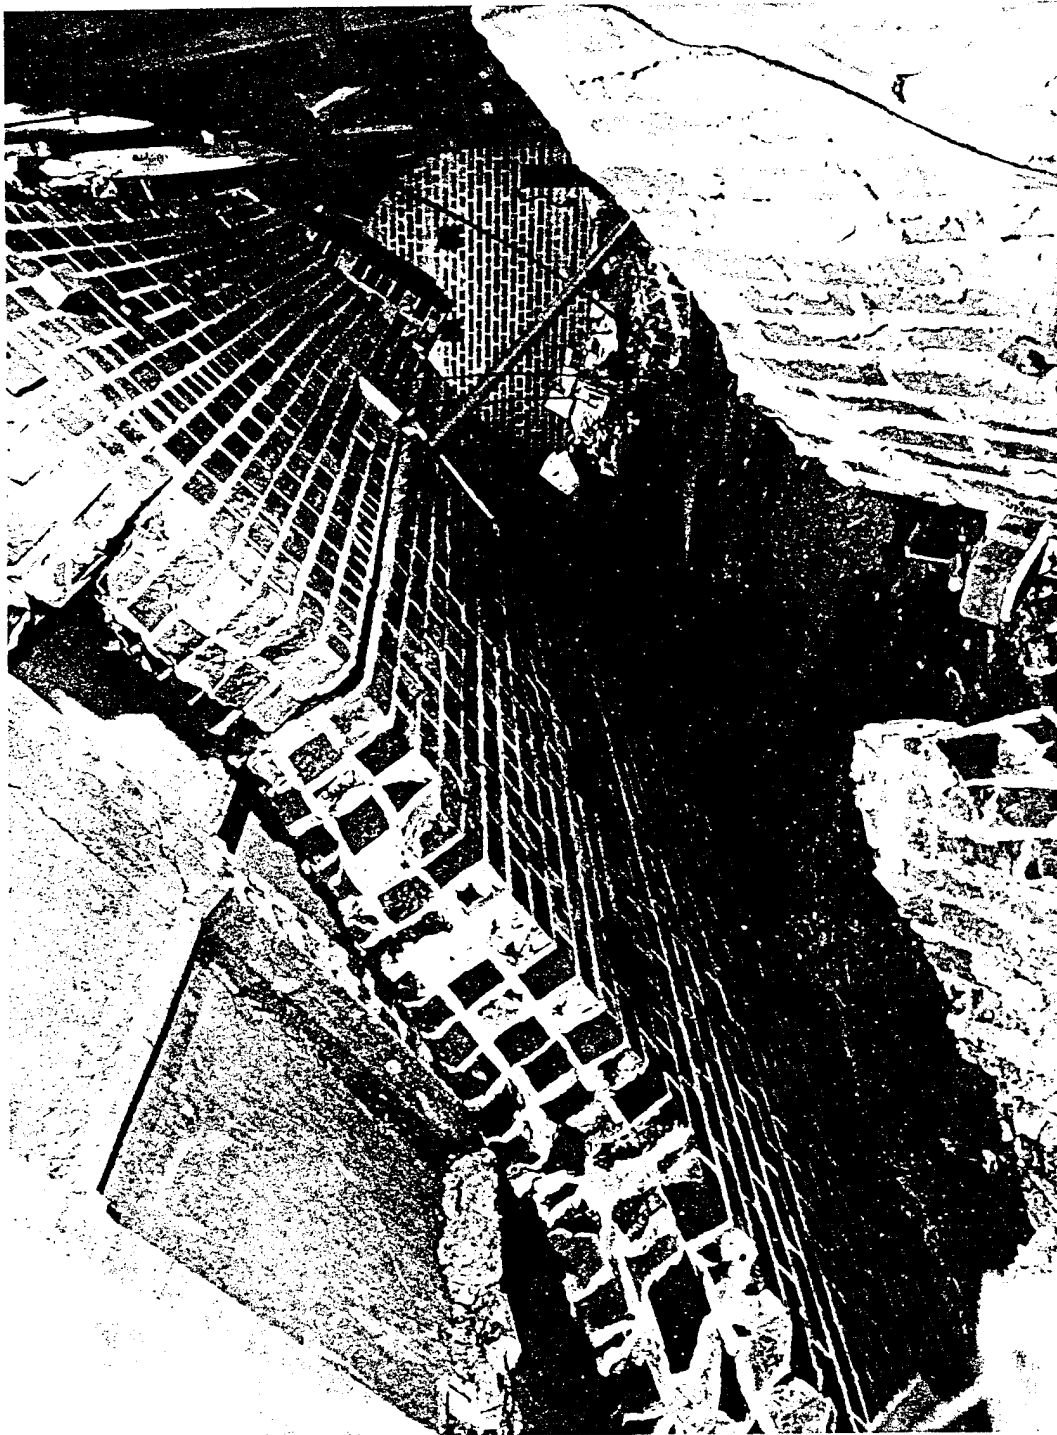
Fig. L.142 Brick Wall Hanging to Underside of Inclined Front Panels, Structure 3.2.2b

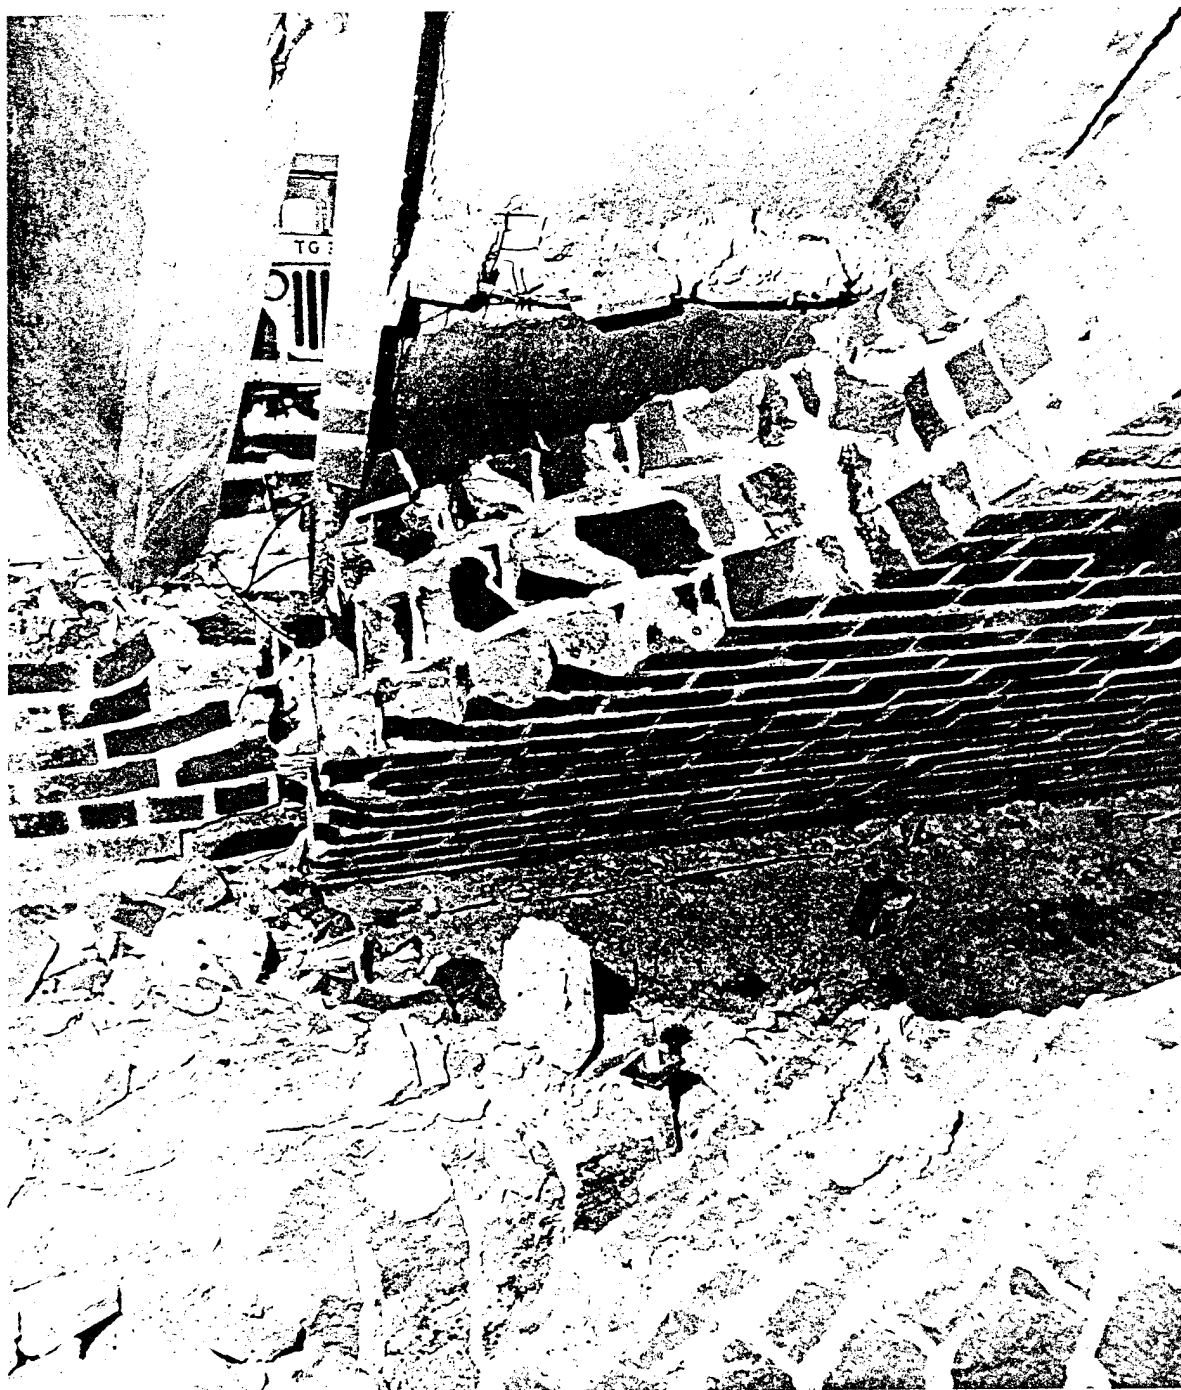
Fig. L.143 Interior Detail Showing Punctured Front-wall Panel, Structure 3.2.2b. Note brick anchor bolt in foreground which has been pulled out.

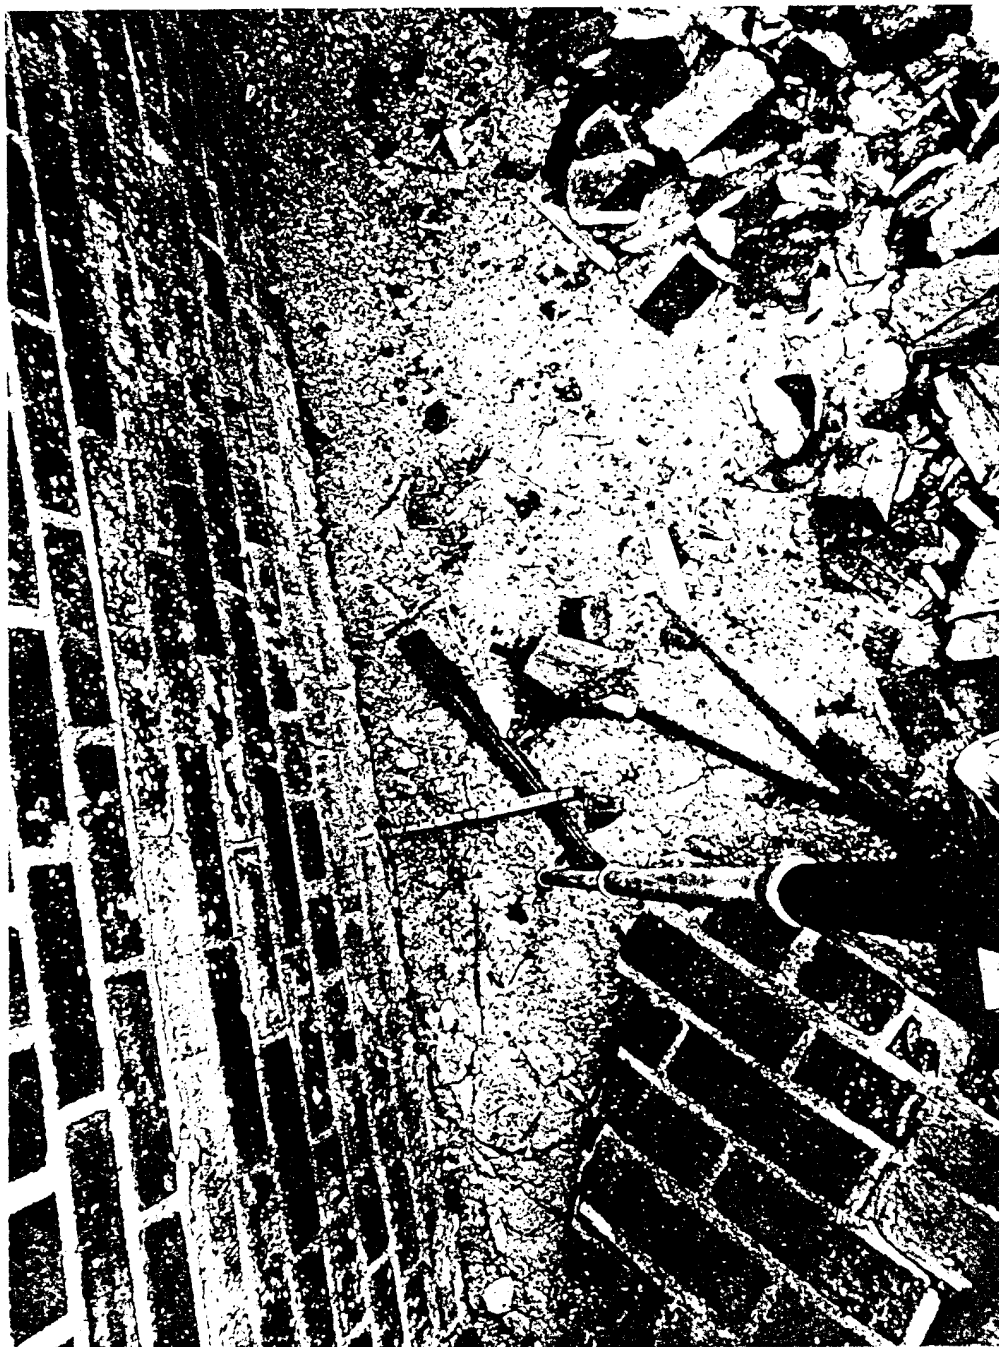
Fig. L.146 Separation along Interior of Right End Wall Between Brick and Earth Due to Blast Pressure on Interior,
Structure 3.2.2b

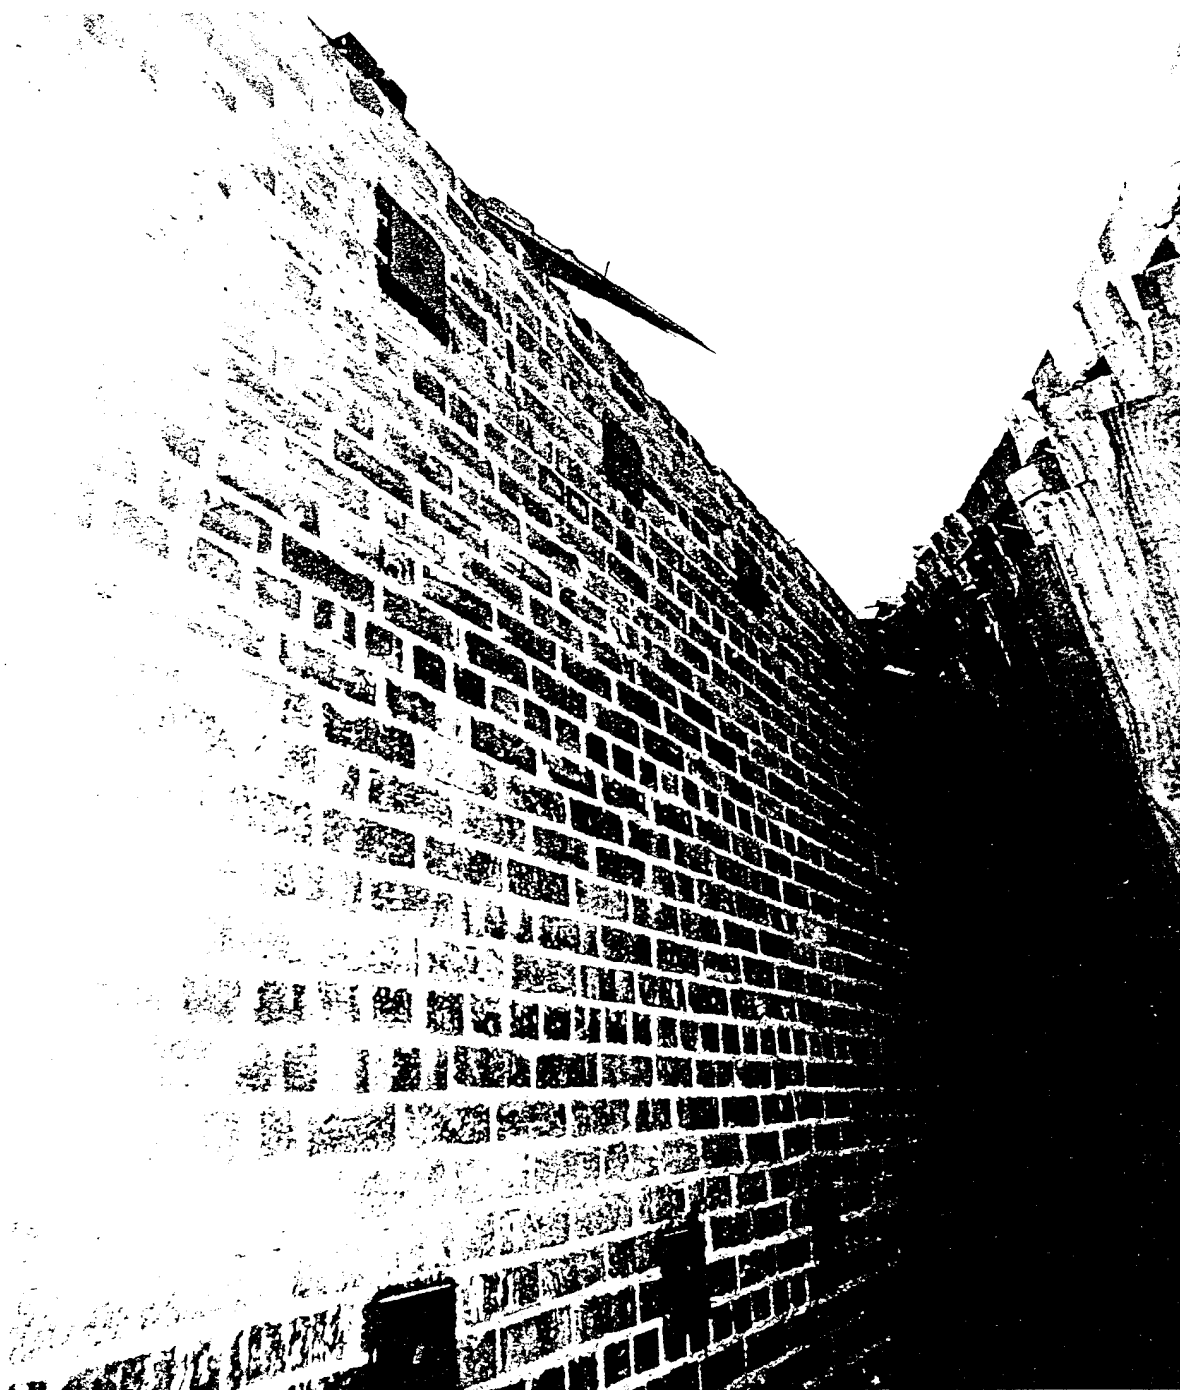
Fig. L.148 Diagonal Crack in Rear Brick Wall, Structure 3.2.2b
